Re: Date of Incident: January 7, 2025
 Location of Incident: Near Eaton Canyon, Altadena, California

The Eaton Fire

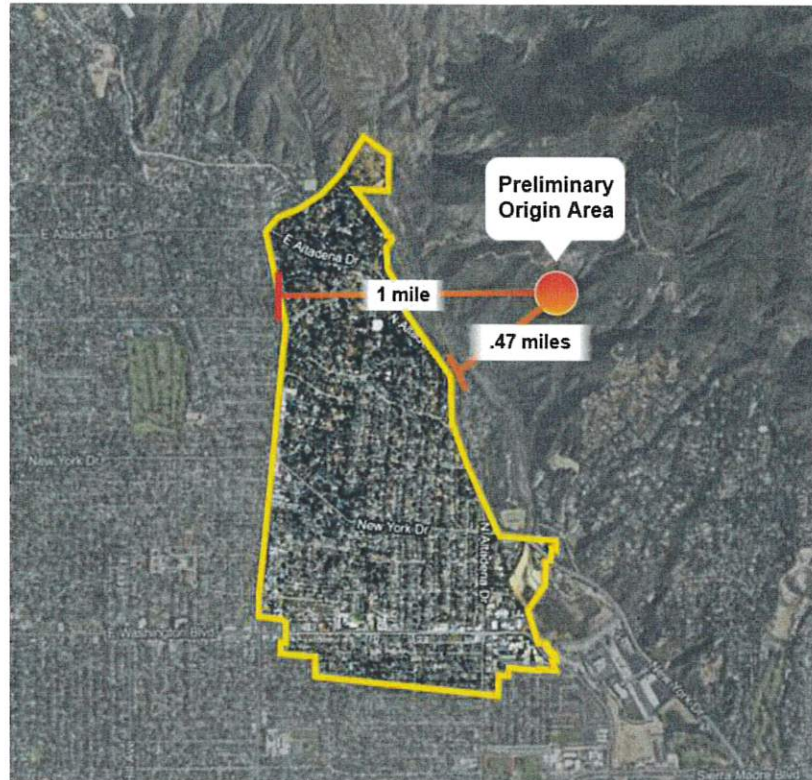
SCE has undertaken extensive work to make its distribution system in Altadena safe and to restore power. Although no fire agency investigator has suggested that the origin of the Eaton Fire occurred anywhere outside of Eaton Canyon itself, some law firms that have filed lawsuits against SCE have nonetheless requested preservation of materials associated with SCE's distribution facilities in the residential neighborhoods adjacent to Eaton Canyon. SCE has documented and is preserving SCE equipment removed from an approximately one-square mile area west of Eaton Canyon in the area of Altadena closest to the fire investigators' preliminary area of origin, as shown in the figure below.

One law firm sought a court order requiring SCE to expand its documentation and preservation of damaged or downed distribution equipment to all of Altadena. The Los Angeles Superior Court did not grant that request. That firm subsequently narrowed its request to equipment along distribution lines in Altadena where faults occurred for an eight-hour period prior to 6:11 p.m. on January 7, which is approximately the time that the Eaton Fire was first reported, and the court did not grant that request. At present, no plaintiff-side law firm or media report has made SCE aware of any specific, credible information that SCE's distribution equipment in Altadena was involved in any ignition on January 7. While a further hearing on evidence preservation is set for February 18, 2025, SCE is working with plaintiff-side law firms to resolve any outstanding issues over the scope of equipment that SCE will preserve. Requiring SCE to preserve additional areas in Altadena may delay repair and clean-up efforts for those areas impacted by the windstorm and fire.
